RF1800033

Assembly Coordinates S Boby Argent

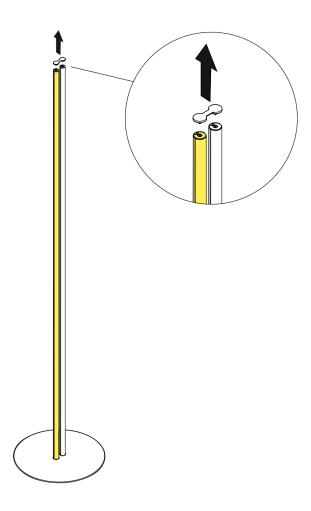
Fig.1

Remove the fixing kit assembly from the body.

Put the fixing kit assembly on the body (Fig.1 page 6).

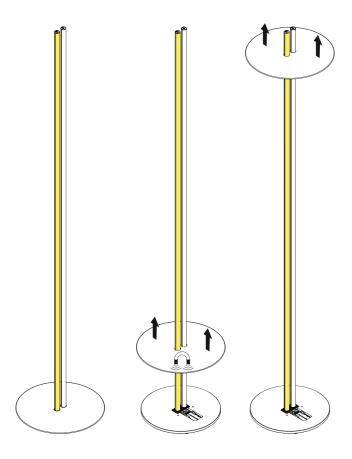
Fig.2

Remove the base upper cover.

Connect the base upper cover (Fig.2 page 7)

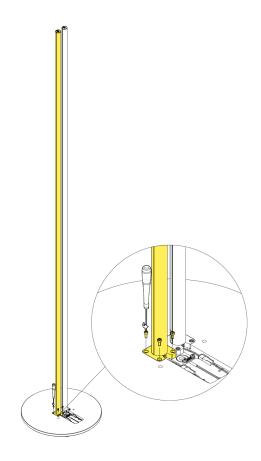
Fig.3

Unfasten the n°4 screws.

Fast the n°4 screws (Fig.3 page 8)

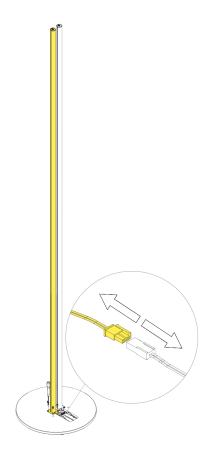
Fig.4

Disconnect the pins.

Connect the pin (Fig.4 page.9)
